# Advanced Radon Services

## Sub Slab Depressurization – Inside Routing

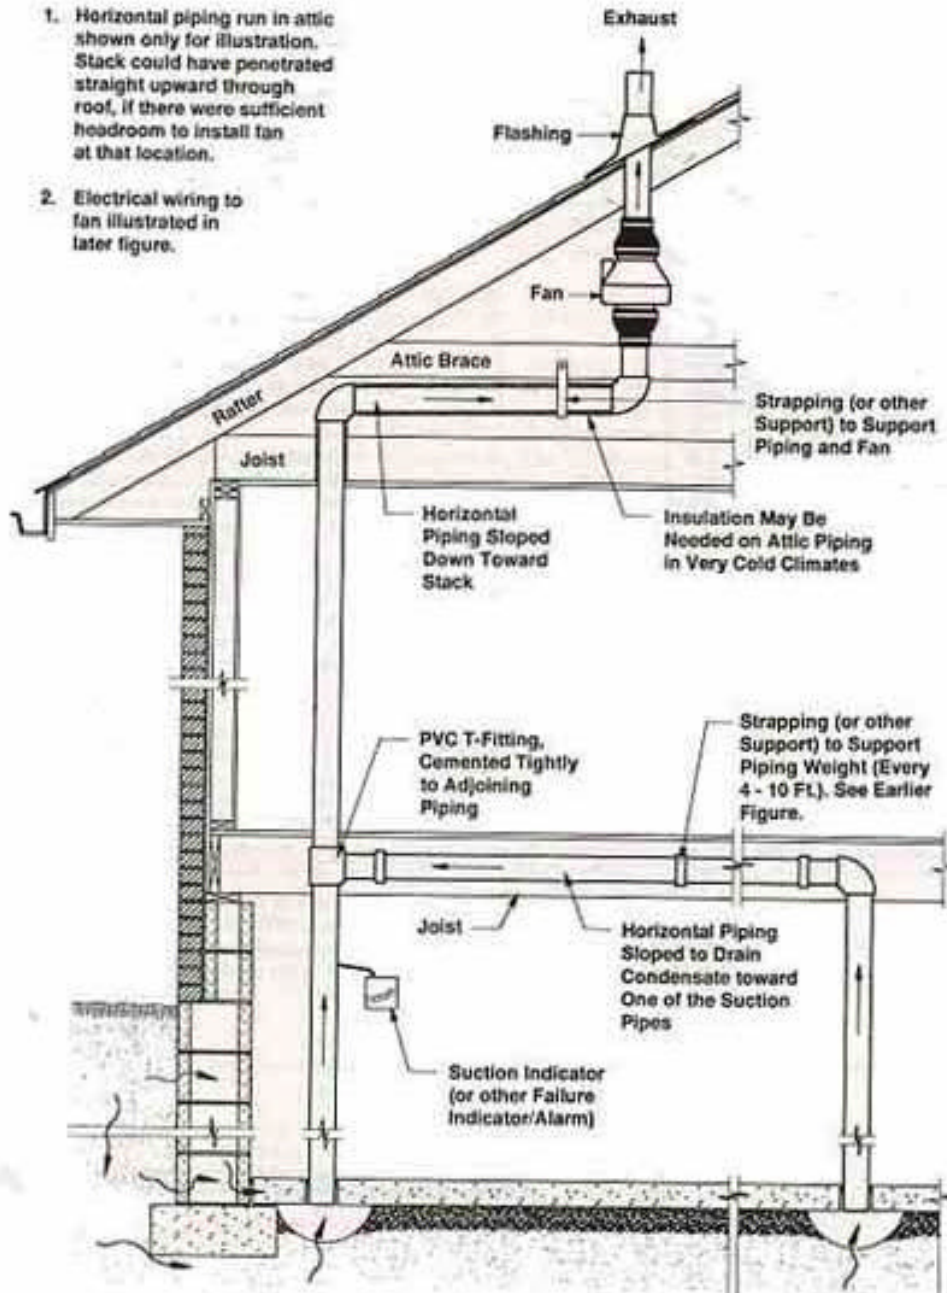
1. Horizontal piping run in attic shown only for illustration. Stack could have penetrated straight upward through roof, if there were sufficient headroom to install fan at that location.
2. Electrical wiring to fan illustrated in later figure.

Routing through an attached garage is simple and cost-effective.
